# Fault Location in Electric Low Voltage Cables for Photovoltaic Systems

**CASE STUDY**

This case of study details the technical inspection carried out on the 1.5 kV DC underground power lines of a solar farm located in the Department of Cesar, Colombia.

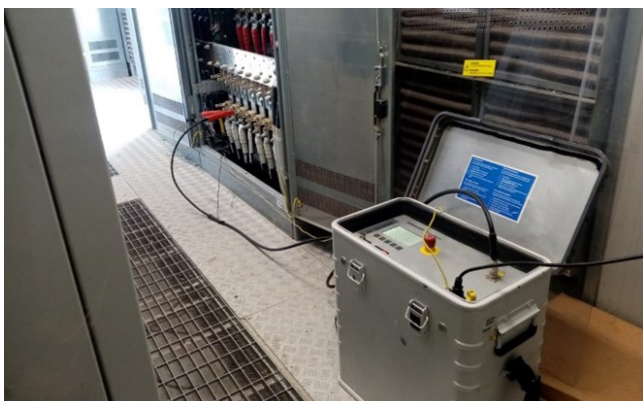
Fig. 1. Hipot DC Test Set. Connections.

The result obtained was 9 out of 28 cables tested were faulty. The figure 1 shows the

test site and hipot DC equipment during the measurements.

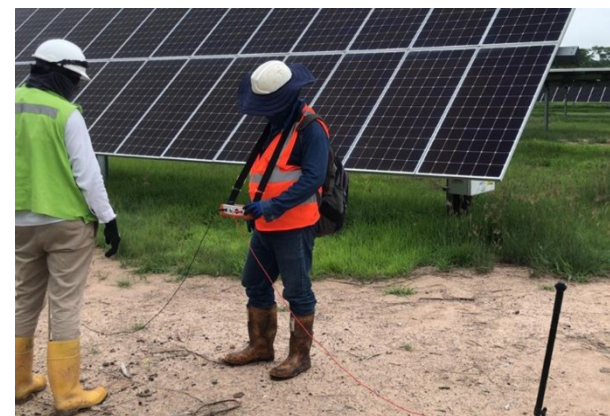
Fig. 2. Pinpointing a fault in buried cable.

It was possible to measure step voltages in the ground with values between 2 mV up to 120 mV around the place where the fault was by using the voltmeter/galvanometer and ground stakes (See figure 2).

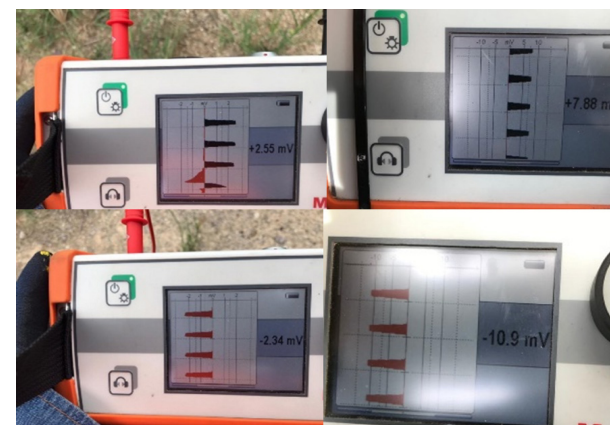
Fig. 3. Pinpointing a fault in buried cable.

Voltage gradient measurements were then applied punctually, considering the failure point as found once the voltage was reduced and changed to opposite polarity as shown in the sequence of measurements shows in figure 3.

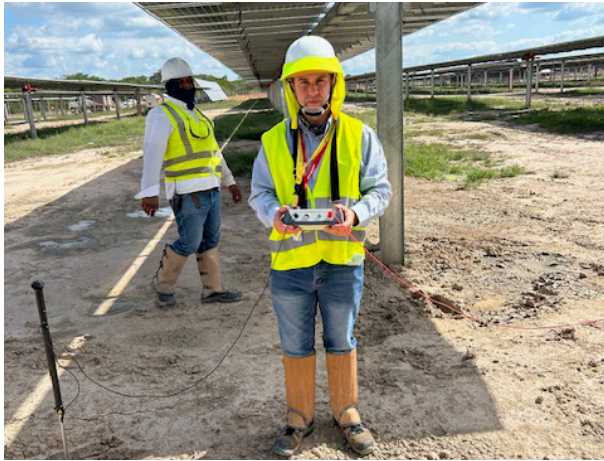
Fig. 4. Pinpointing a fault in buried cable.

The figure 4 shows the exact cable fault location.

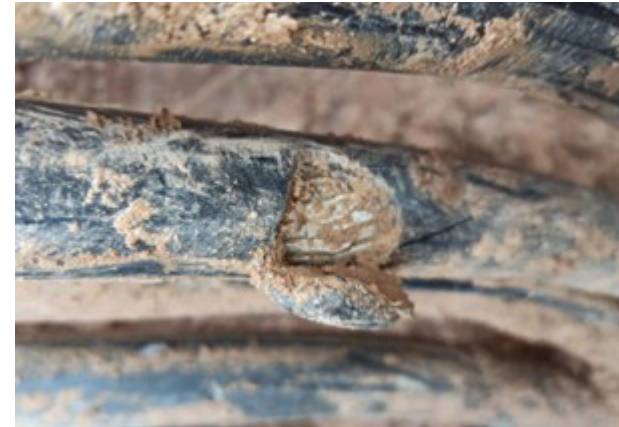
Fig. 5. Damage found in the cable during installation.

- The integrity of the jacket was verified applying hipot DC up to 1.8 kV.
- All faults were located promptly using the methodology previously described
- It is worth mentioning that most of the damages found after the excavation of the failed cables show cuts, cracks and/or dents that must have been caused by the action of external agents, probably at the time of installation or laying of the cable in trenches. See damages found in figures 5 to 7.

To carry out a proper repair of jacket faults, the following procedure is recommended:

Clean the affected area and scrape the jacket at the fault location with a blunt pointed cutting tool to avoid accidentally causing another fault.

Check the depth of the fault to determine if the damage is only surface or if it has perforated to the center conductor.

In case of surface fault is only on the cable sheath, insulating Tape is applied to the well-cleaned area or vulcanizing tape can be used and covered by insulating tape.

If the damage has reached the center conductor, a new joint or splice must be installed as a final repair following the installation procedures recommended by the manufacturer selected.

It is very important to evaluate the backfill used in the installation. As required by National Electric Code NFPA70 [2], backfill containing large rocks and very angular elements will not be placed to avoid further damage during backfill compaction. Once the cable has been repaired, it should be backfilled with granulated or fine sand and subsequently, it is recommended that the cable sheath be retested according to the procedure initially described in this report.

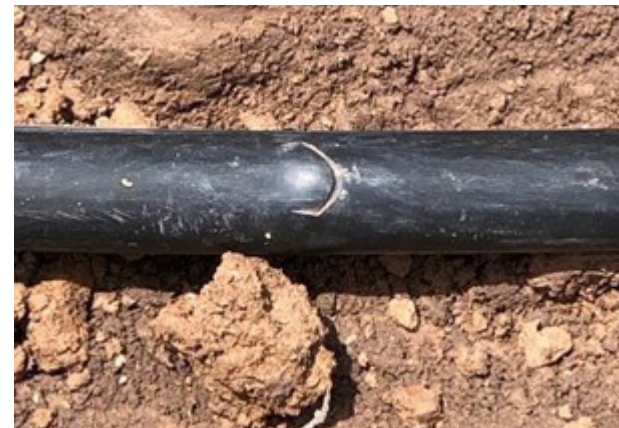
Fig. 6. Damage found in the cable during installation.

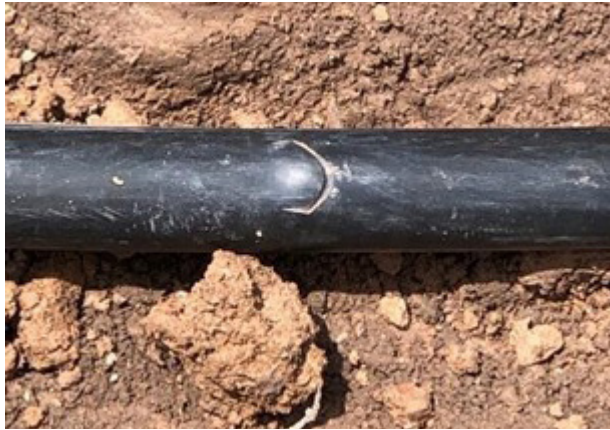
*Fig. 7. Damage found in the cable during installation.*
