A toolbox approach to fault location in LV power cables

Background

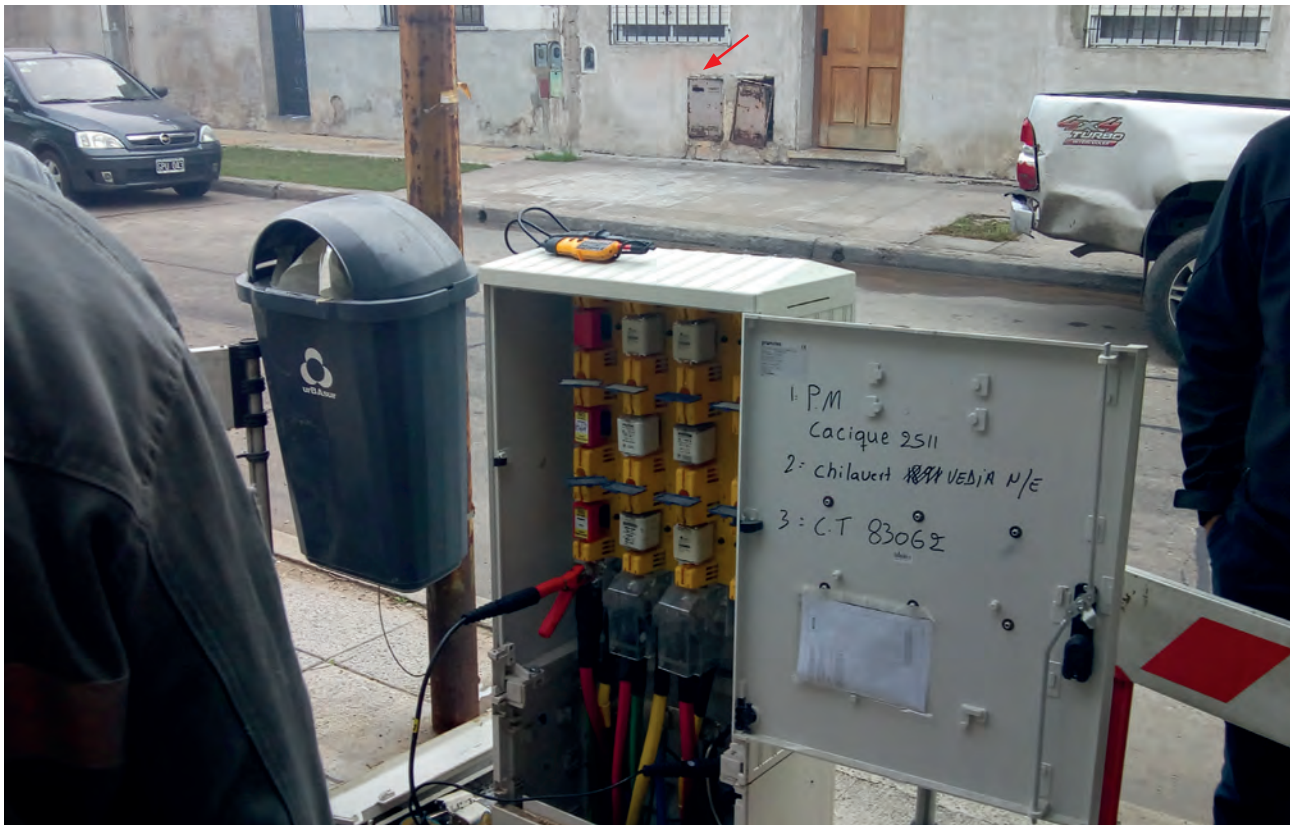
Figure 2: Typical residential three-phase fuse cabinet

The fault involved a section of four-conductor (three phase conductors, one neutral) residential LV cable with steel armor, as shown in Figure 1. The section of cable was approximately 100 m long and ran between two fuse cabinets (Figure 2). It serviced three homes, each via a T-splice. The splices were around 30 m apart.

Before fault location commenced, the fuses in each individual house service box within the cable section were removed (see Figure 2, where a typical box on the opposite side of the street is highlighted with a red arrow). Care was taken to maintain adequate clearance between the contact points in the fuse box (or termination box) so that the test voltage, which was higher than the normal operating voltage, could be safely applied.

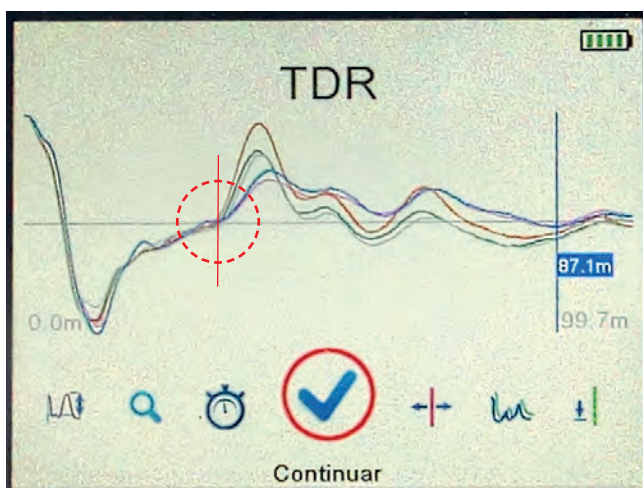
Figure 3: TDR traces, comparison of conductor pairs

2. A similar routine was adopted with the TDR, comparing the traces of all ten conductor pairs with each other, as shown in Figure 3.

Because the TDR mode is not an HV mode, it could be activated without the HV return bonded to ground, so the results reflect the true impedance between conductors and between all four conductors and the armor (= ground). The TDR could see the cable end at about 110 m, and the traces showed very good

superimposition from left to right as far as the vertical red line, which represents a distance of about 29 m from the connection point. At this distance, all traces (representing the conductor pairs) showed an increase in impedance to varying degrees. This corresponds with the measurement of different IR values between the pairs. This result confirmed the suspicion that all conductors had a fault at the same location, which was once again a strong indication of a possible failure in one of the T-splices.

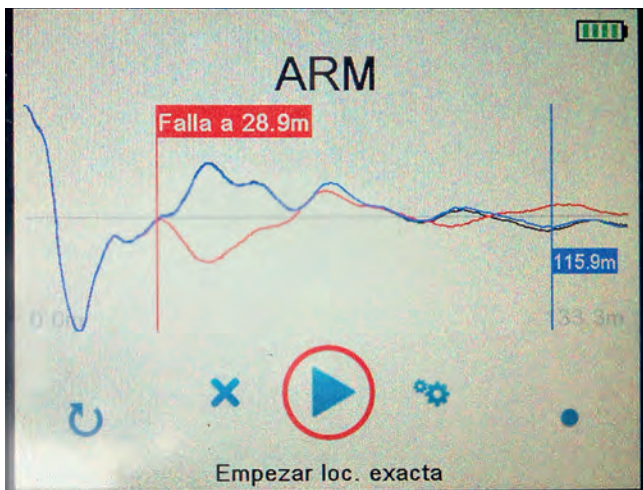
Figure 4: ARM localization of fault

In this investigation, the two conductors with the largest IR difference (L1 and L3) were selected in order to have the best chance of creating a flashover (see Figure 4). The capacitor of the EZ-Thump 3 was charged to the full 3 kV, which provides 500 J of surge energy. With the aid of an energy-efficient inductive-type ARM filter, the ARM fault trace showed the fault at almost the same distance – 29 m – as previously identified by the conductor pair comparison method.

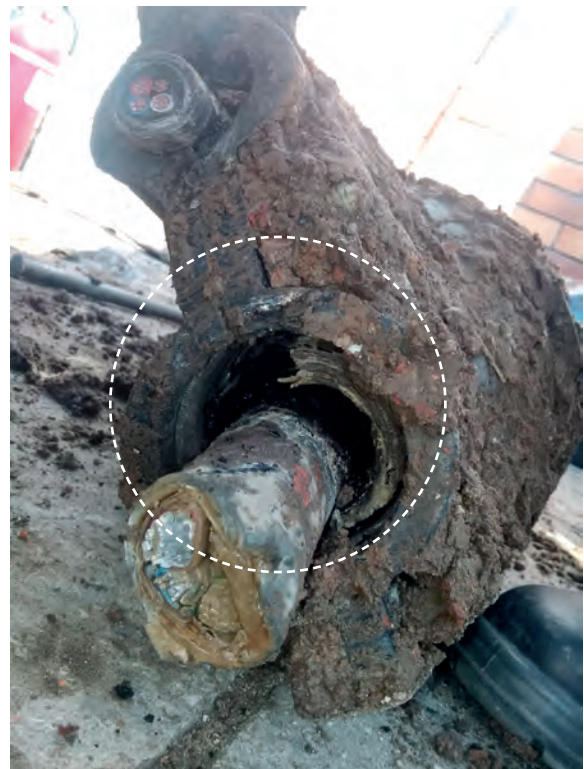
Figure 7: T-splice showing 'trunk' cable and smaller 'branch' cable (feeding house service)

The EZ-Thump 3 was switched to thump (surge) mode at a voltage of 3 kV, delivering 500 J. Based on the TDR and ARM results and knowledge of the cable path, pinpointing was started at around 29 m and the exact fault location was quickly found, showing as a 'bull's-eye' on the display of the DigiPHONE+ Pinpointer (see Figure 5). The location of the defective splice is shown in Figure 6, and the splice itself in Figure 7.

The fifth method, the step potential or voltage gradient method, could not be used to pinpoint this low-resistance fault because the fault was in a splice and the armor was bonded to the metal splice case. Generally, this method cannot be used with armored cables.
